Case Study: 2

Client: Private homeowner
Location: North London
Installers: CSL London

Case Study: 1

Client: Private homeowner
Location: Hampstead, London
Installers: CSL London

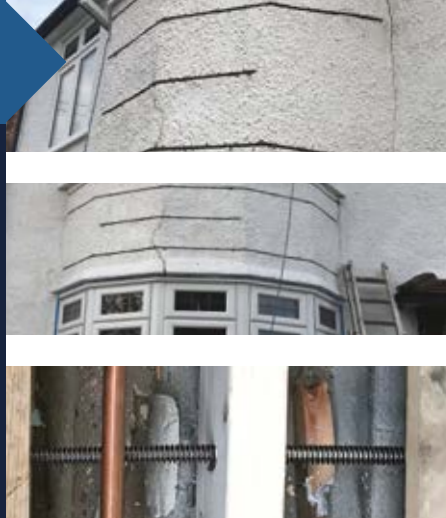
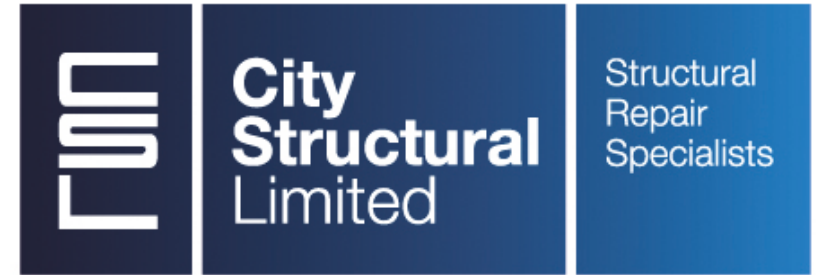
Bay window in north London coming away from main structure due to new UPVC windows being installed. Masonry beams installed and returned to internal, also LRTs installed from the outside into the first floor joists. The specification is designed to stop any further outward movement.

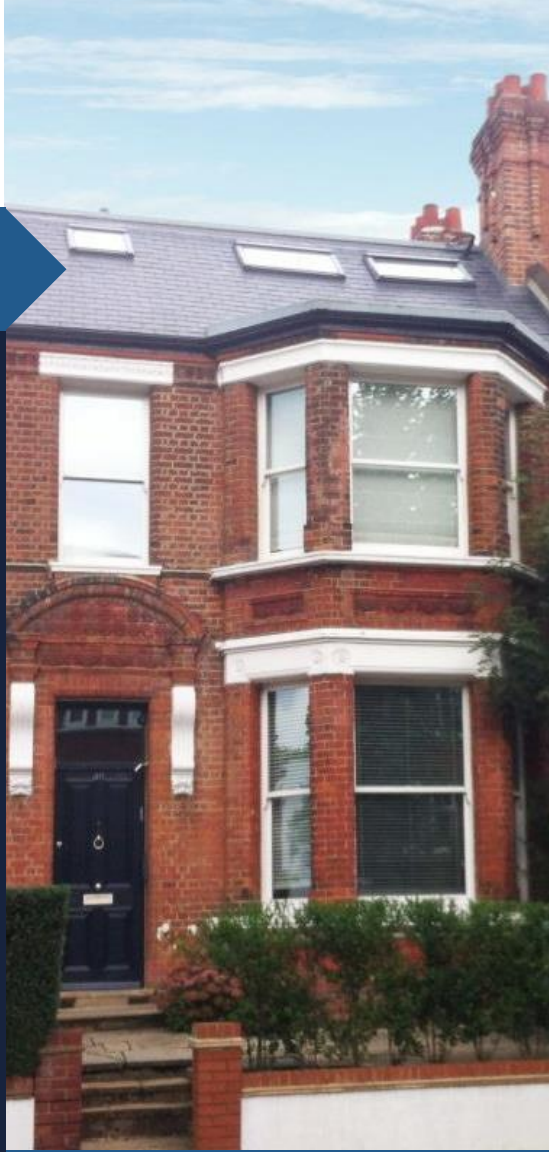
Two storey semi-detached property in Hampstead north London various masonry cracks had developed around the ground floor bay window.

External vertical cracking was 2mm wide at ground level widened to 7mm at the window sill on the left hand side of the bay window with further vertical cracking at the internal ground floor return of bay. On the right hand side of the bay there was 2mm cracking from the ground to the sill.

The problem had been caused by differential movement occurring between the bay window and the underpinning of the basement, carried out two years earlier to the left of front door and to the neighbouring property.

Pairs of stainless steel HeliBars were installed at two levels around both the ground and first floor bays. Having channelled-out the mortar beds, the HeliBars were bonded into the slots with HeliBond grout. The ends of the HeliBars were bonded at a 45° angle into holes pre-drilled into the main structure.

The internal cracks were also stitched using HeliBars. Mortar beds were channelled-out across the front and sides of the bay at alternating heights. At the internal corners the bared ends were bent and bonded into the adjoining wall.
